United Federation of Teachers
A Union of Professionals

PCBs in Schools

UFT Safety & Health Department

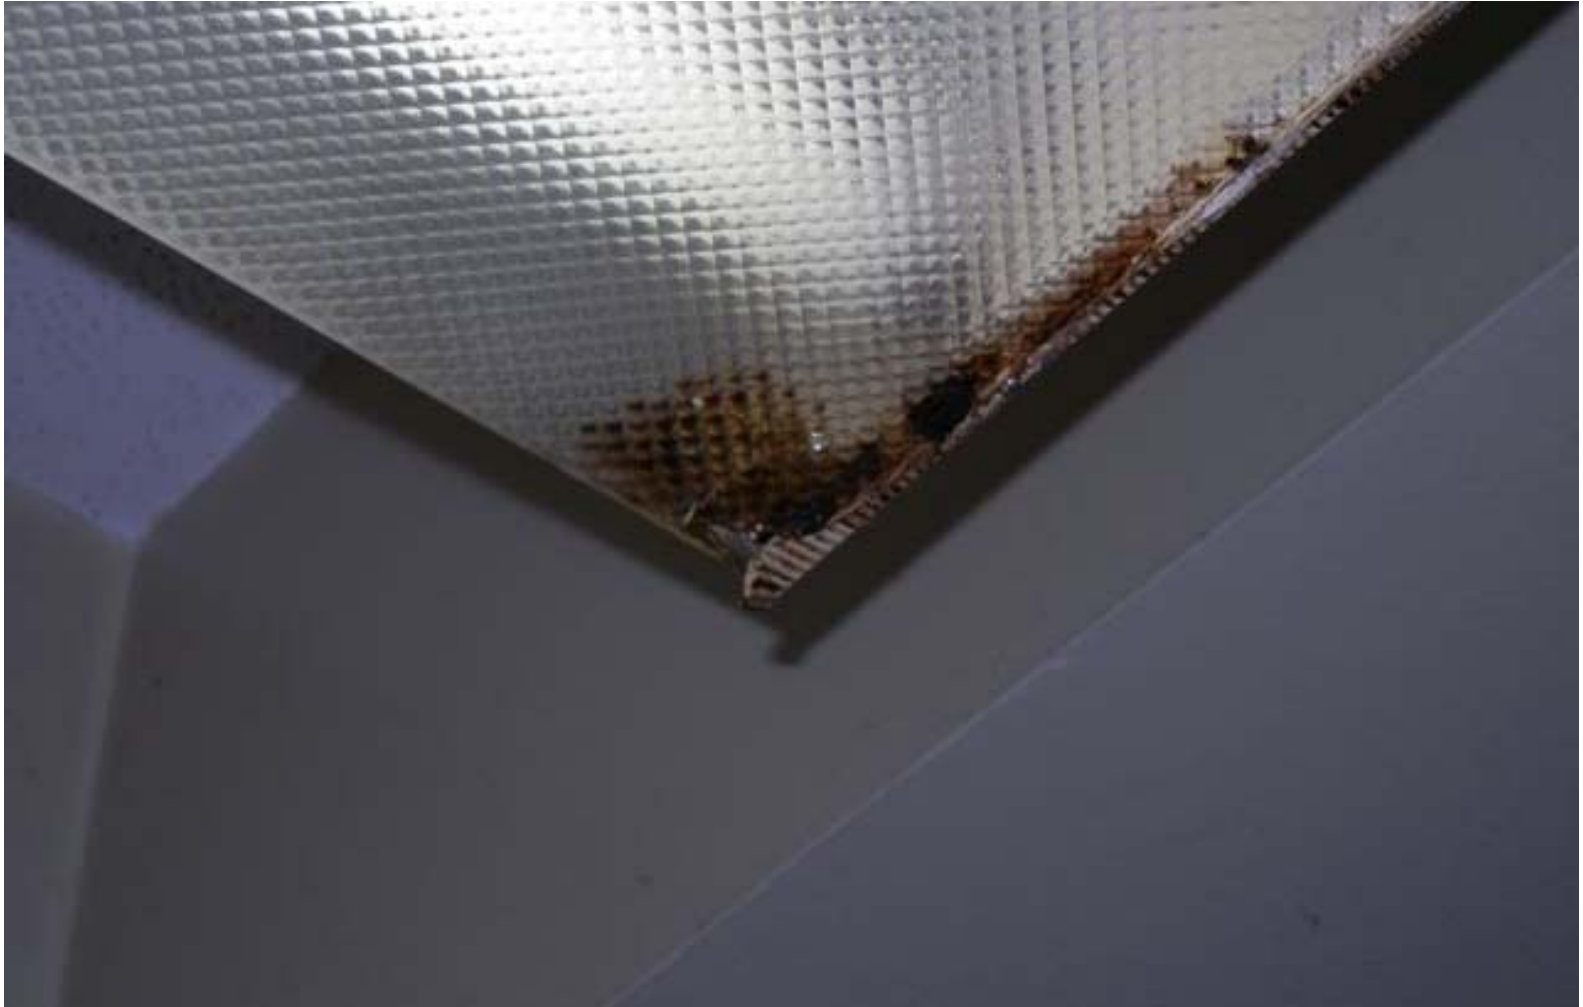
Light Fixture with PCB oil

- Oil dripped from burning light ballast staining fixture and floor below
- Teacher was told to clean up the material
- UFT conducts a site visit and requests EPA investigate
- Tests for PCBs are positive
- UFT meeting with parents and councilman in Staten Island UFT office.
- SCA inspects, removes and replaces the PS 36R light fixtures throughout the building

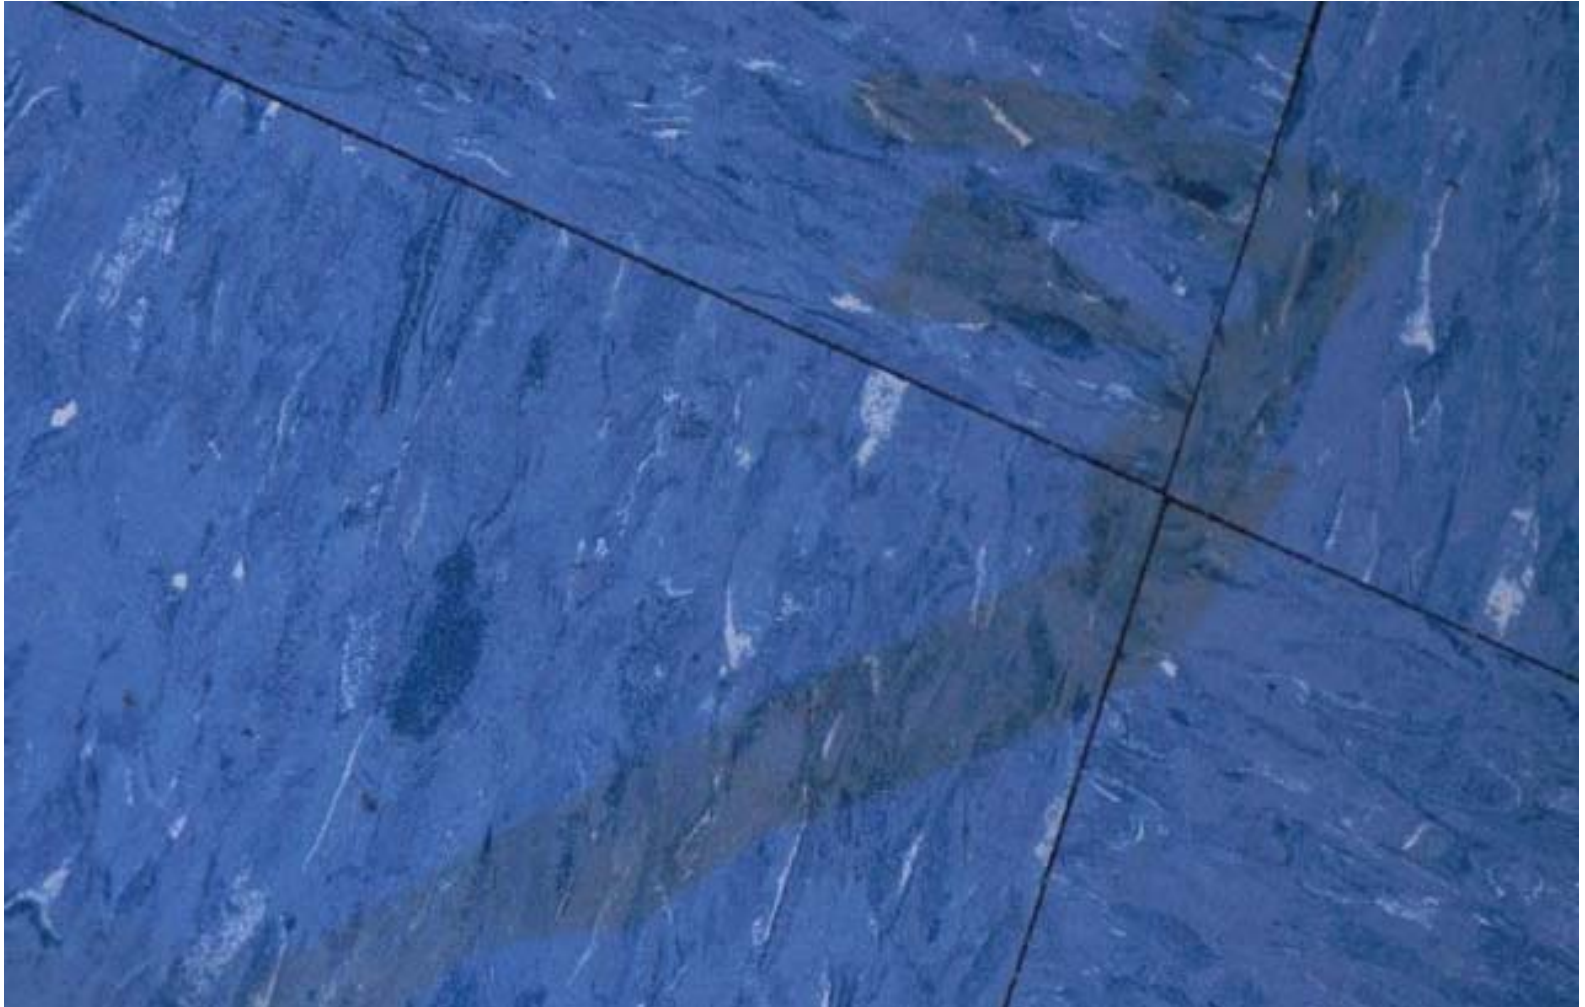
PCB oil stains on floor tile

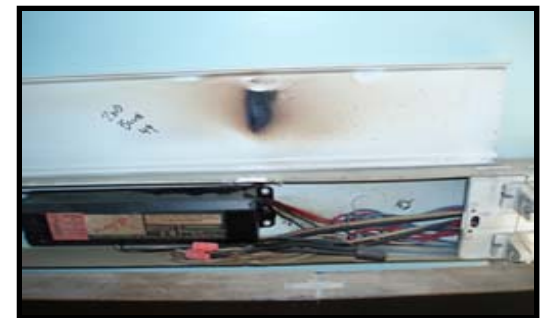
Light Ballasts

- PCB oil in the capacitor inside the ballast and sometimes in potting material in the ballast
- The capacitor can leak or overheat as the ballasts ages
- The PCB contaminated oil and potting material can drip into the fixture or to the floor below.
- The heating due to electrical failure can drive smoke including PCBs into the air
- Light fixture may still work with leaking ballast

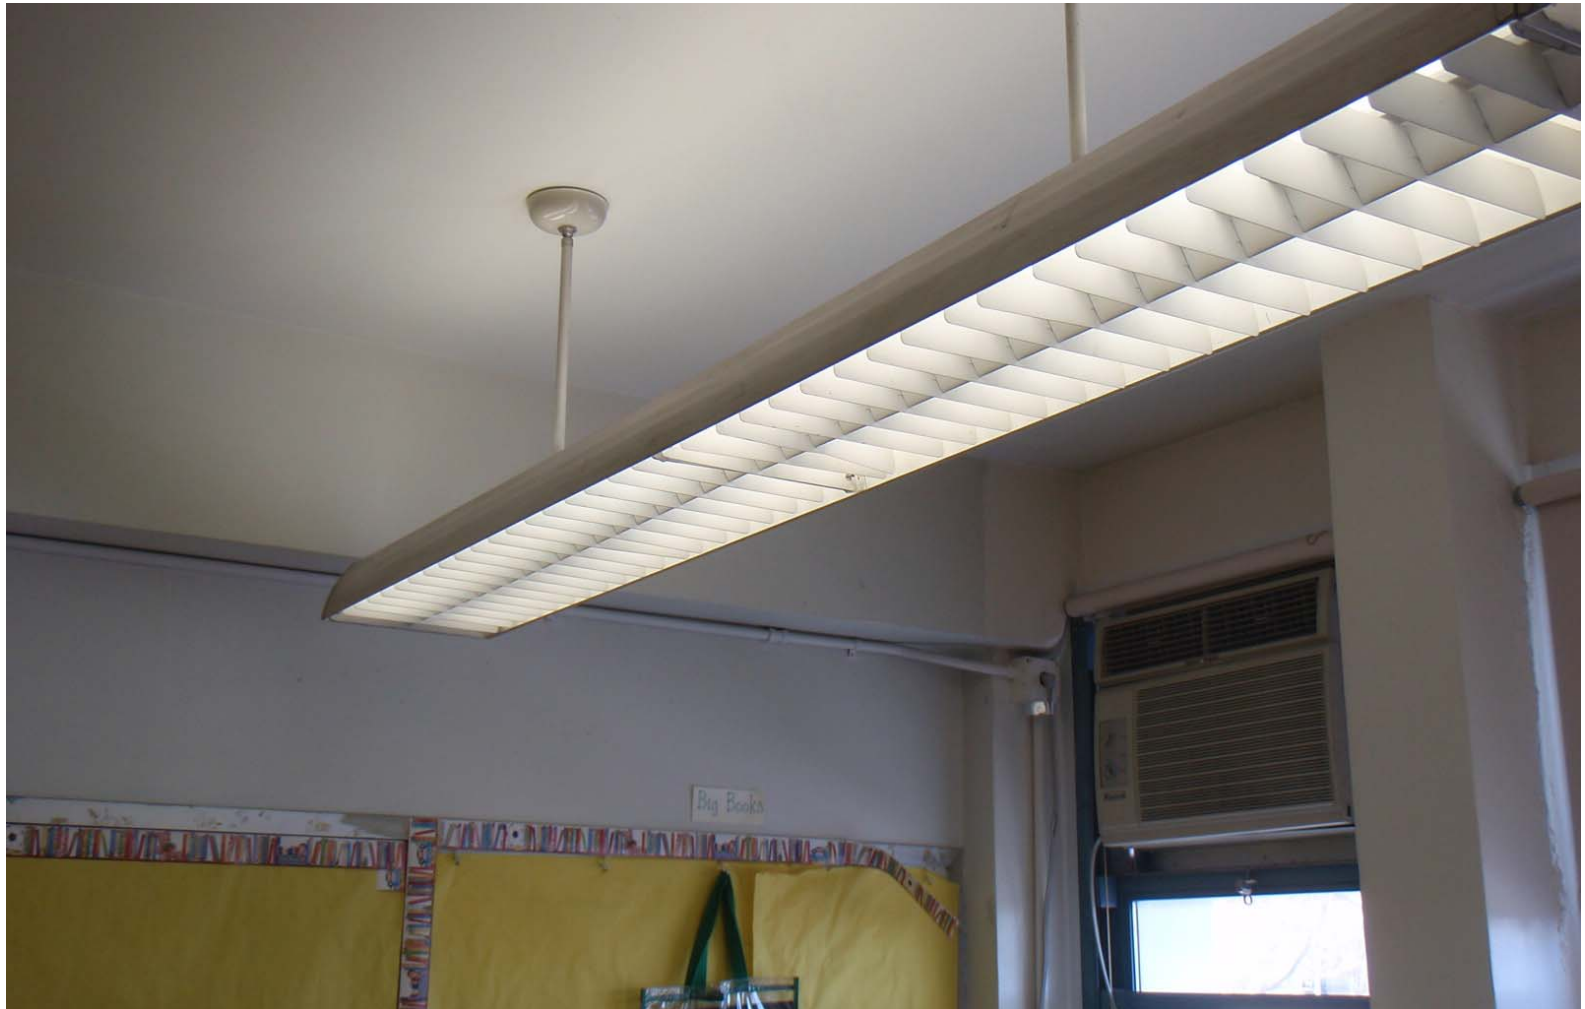
Egg Crate Light Fixtures

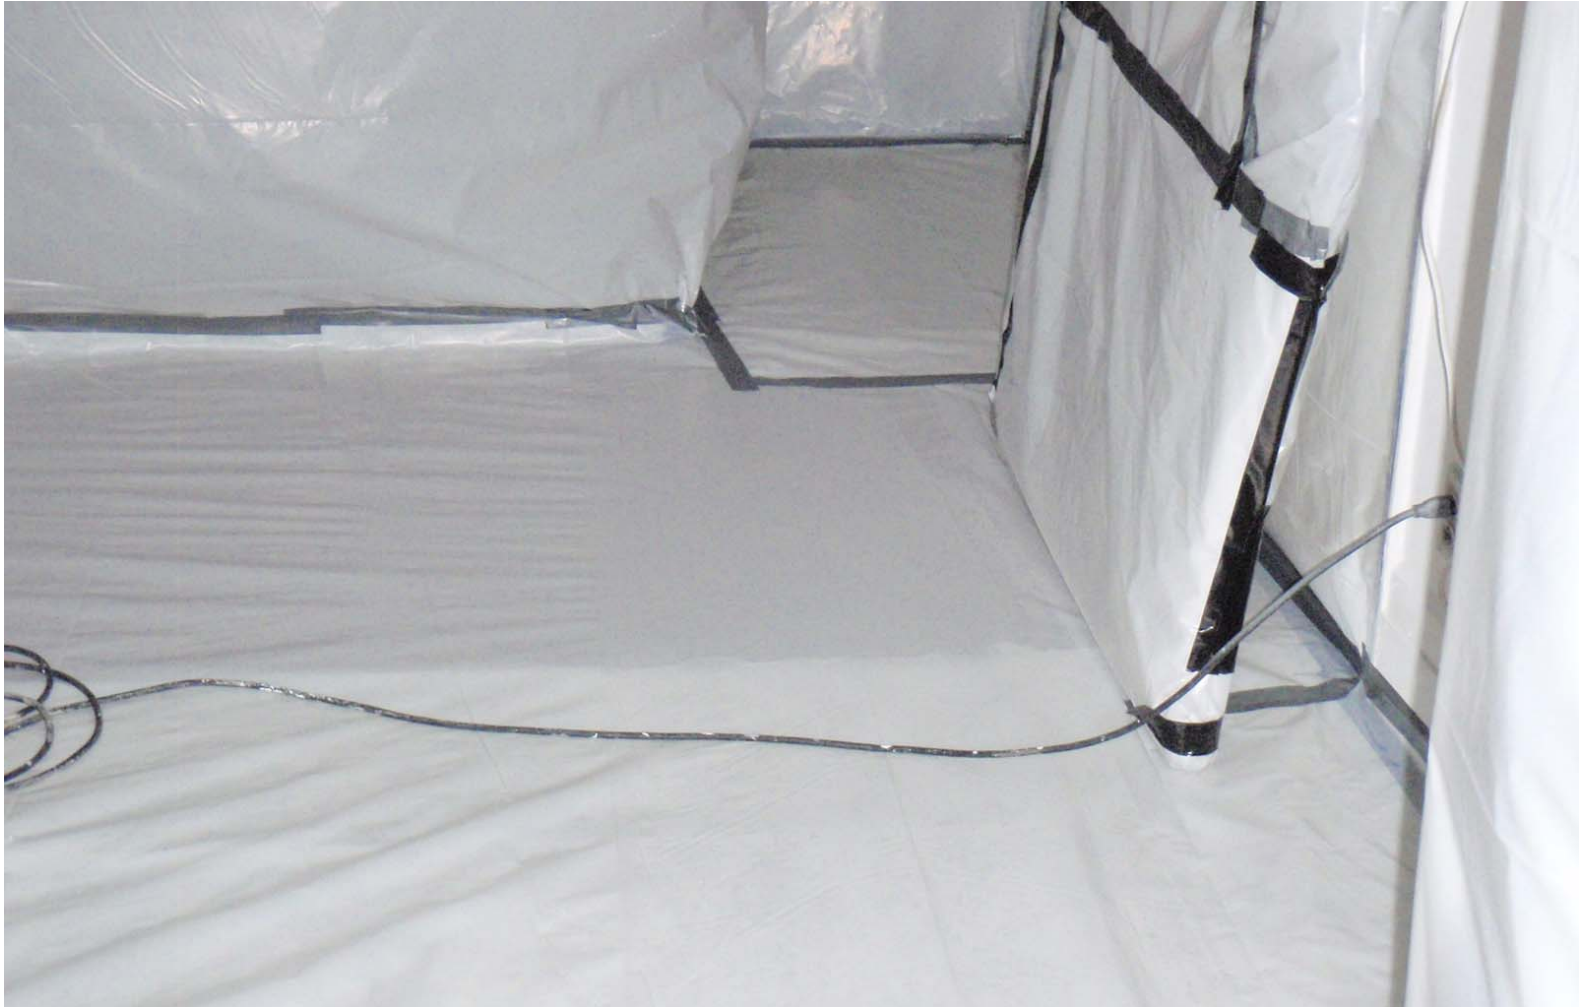
Work area protection

- Often the wiring has asbestos insulation
- NYCDEP worked with SCA and DCAS to develop a protocol for removing fixtures
- Room contents and surfaces were protected
- Ballasts disposed of as PCB waste
- Spring and Summer of 2011 was first round of light fixture projects as part of DOE's NYC Schools Comprehensive Plan

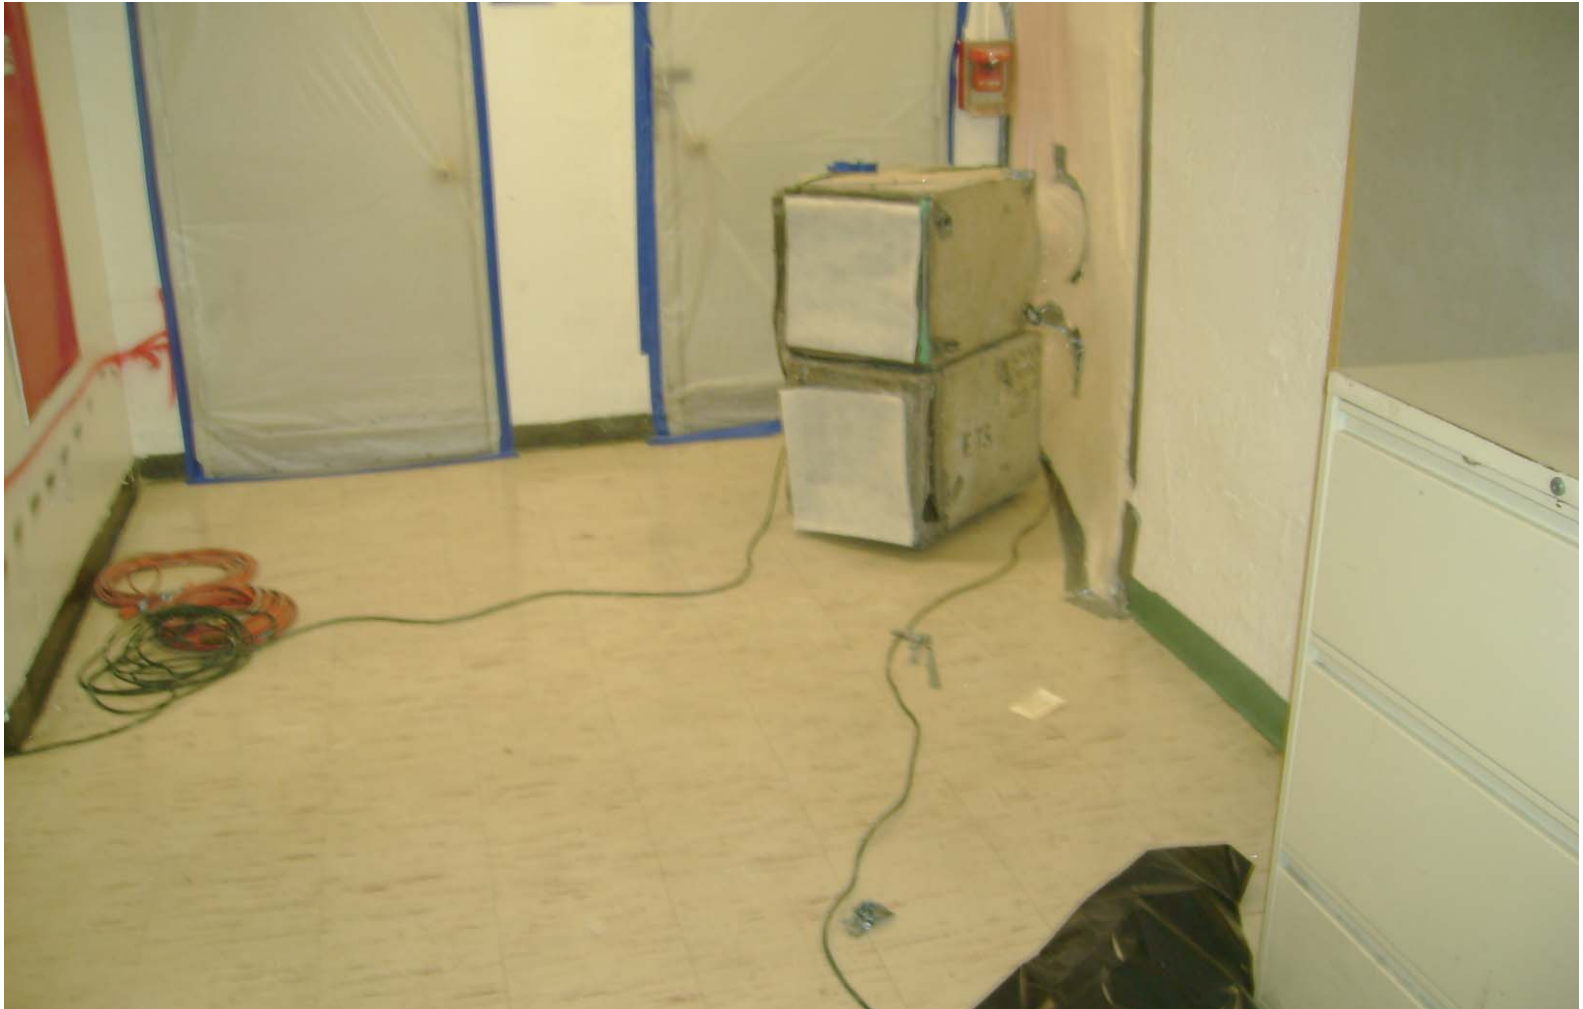
Negative pressure units

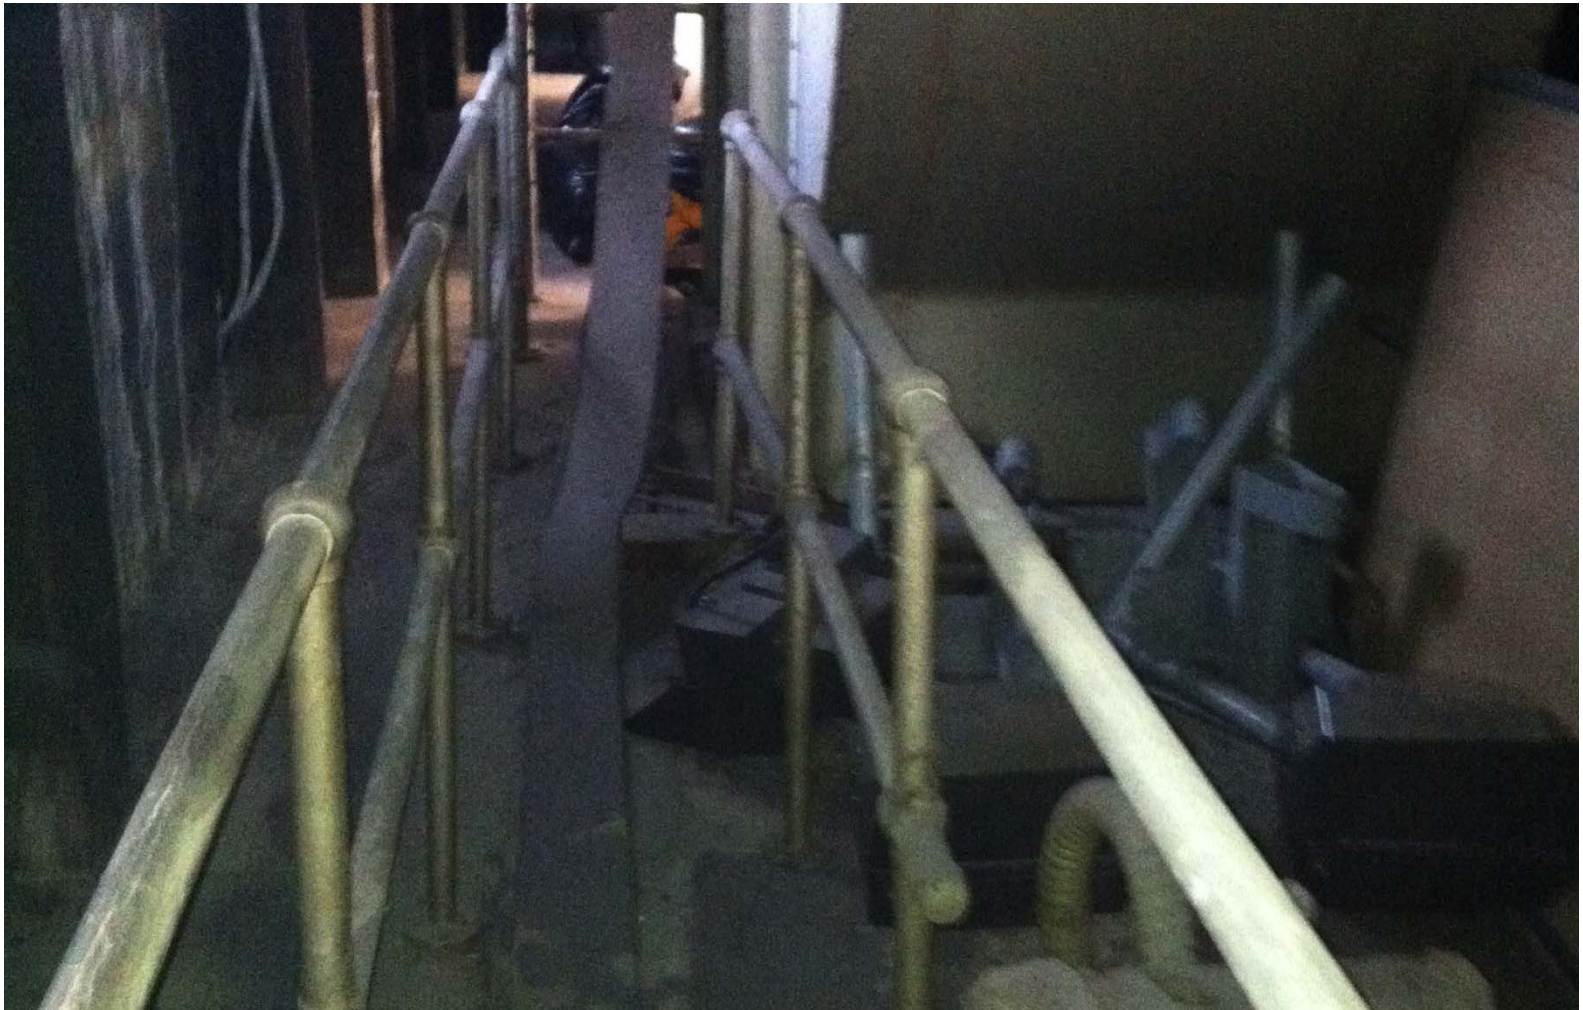
Broken school exhaust fan

- Maintain ventilation systems in good working order
- Custodian inspects lights periodically
- When fixture fails and dripping material, smoke or burning odors are observed, the DOE protocol is to evacuate the room and an environmental contractor responds quickly to inspect and remove the light fixture.

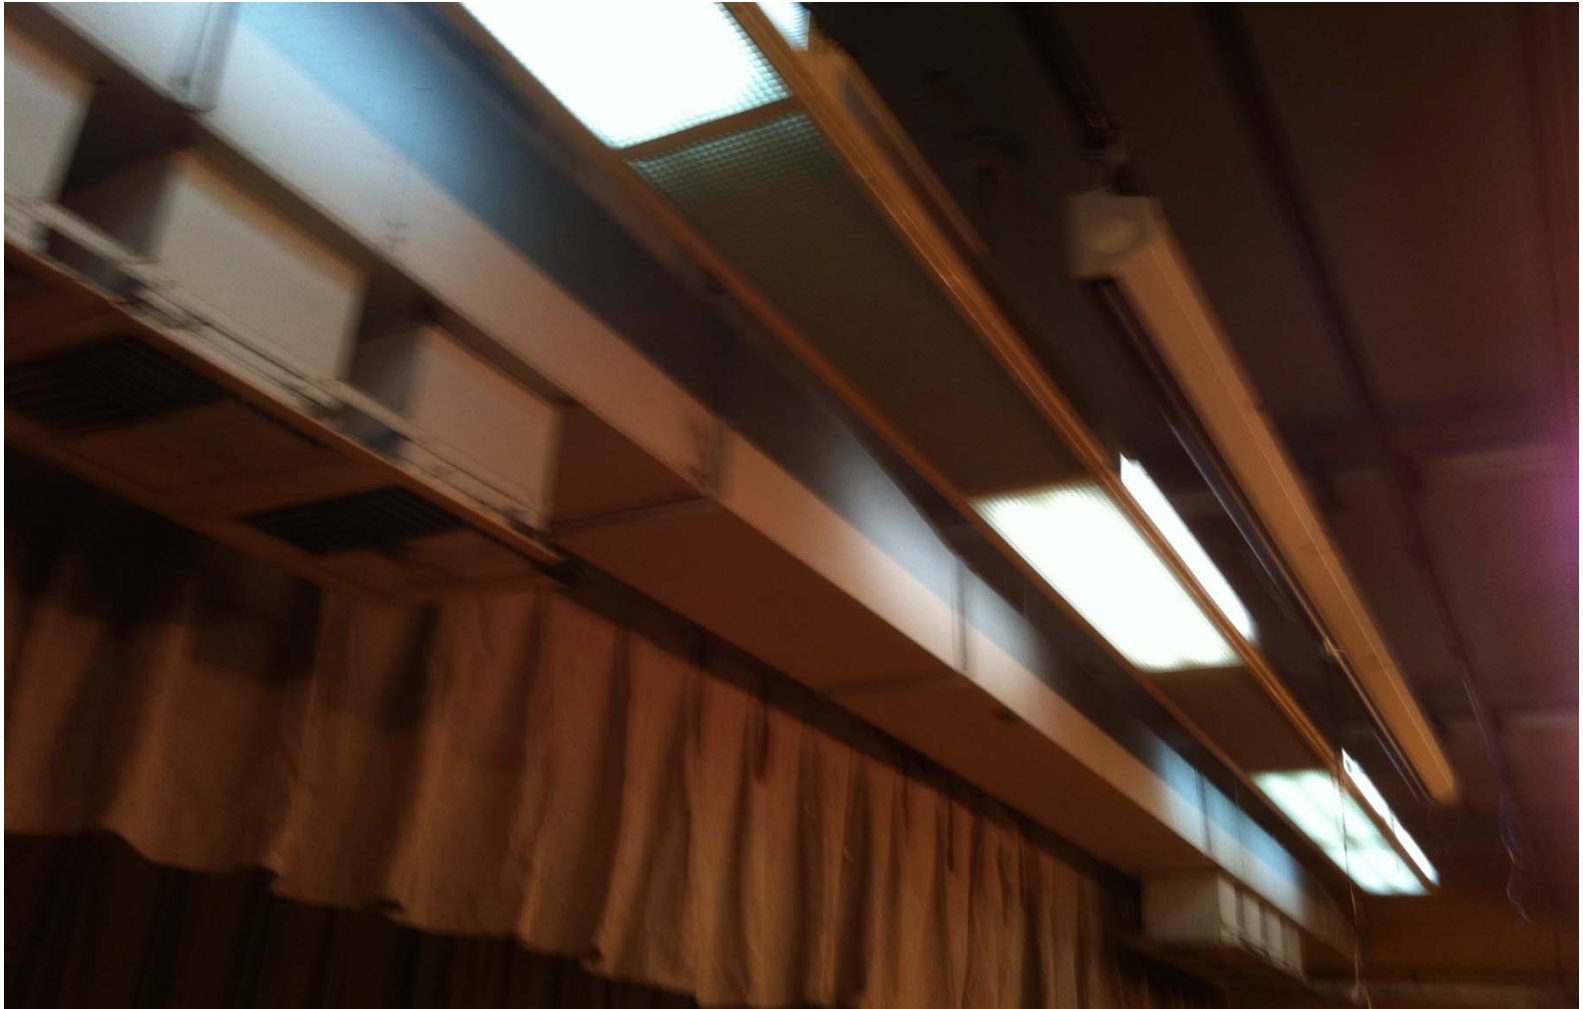
Failing lights due to bad ballast
